A Tribute to a Korean Clock

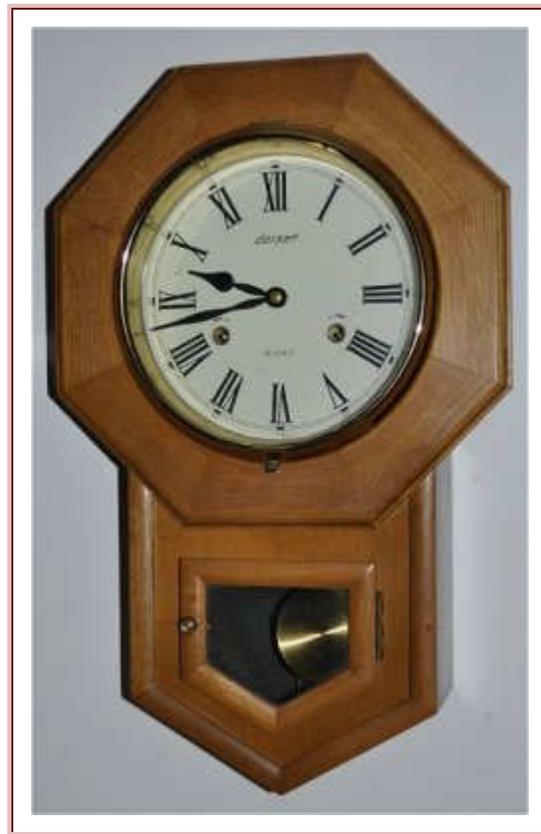
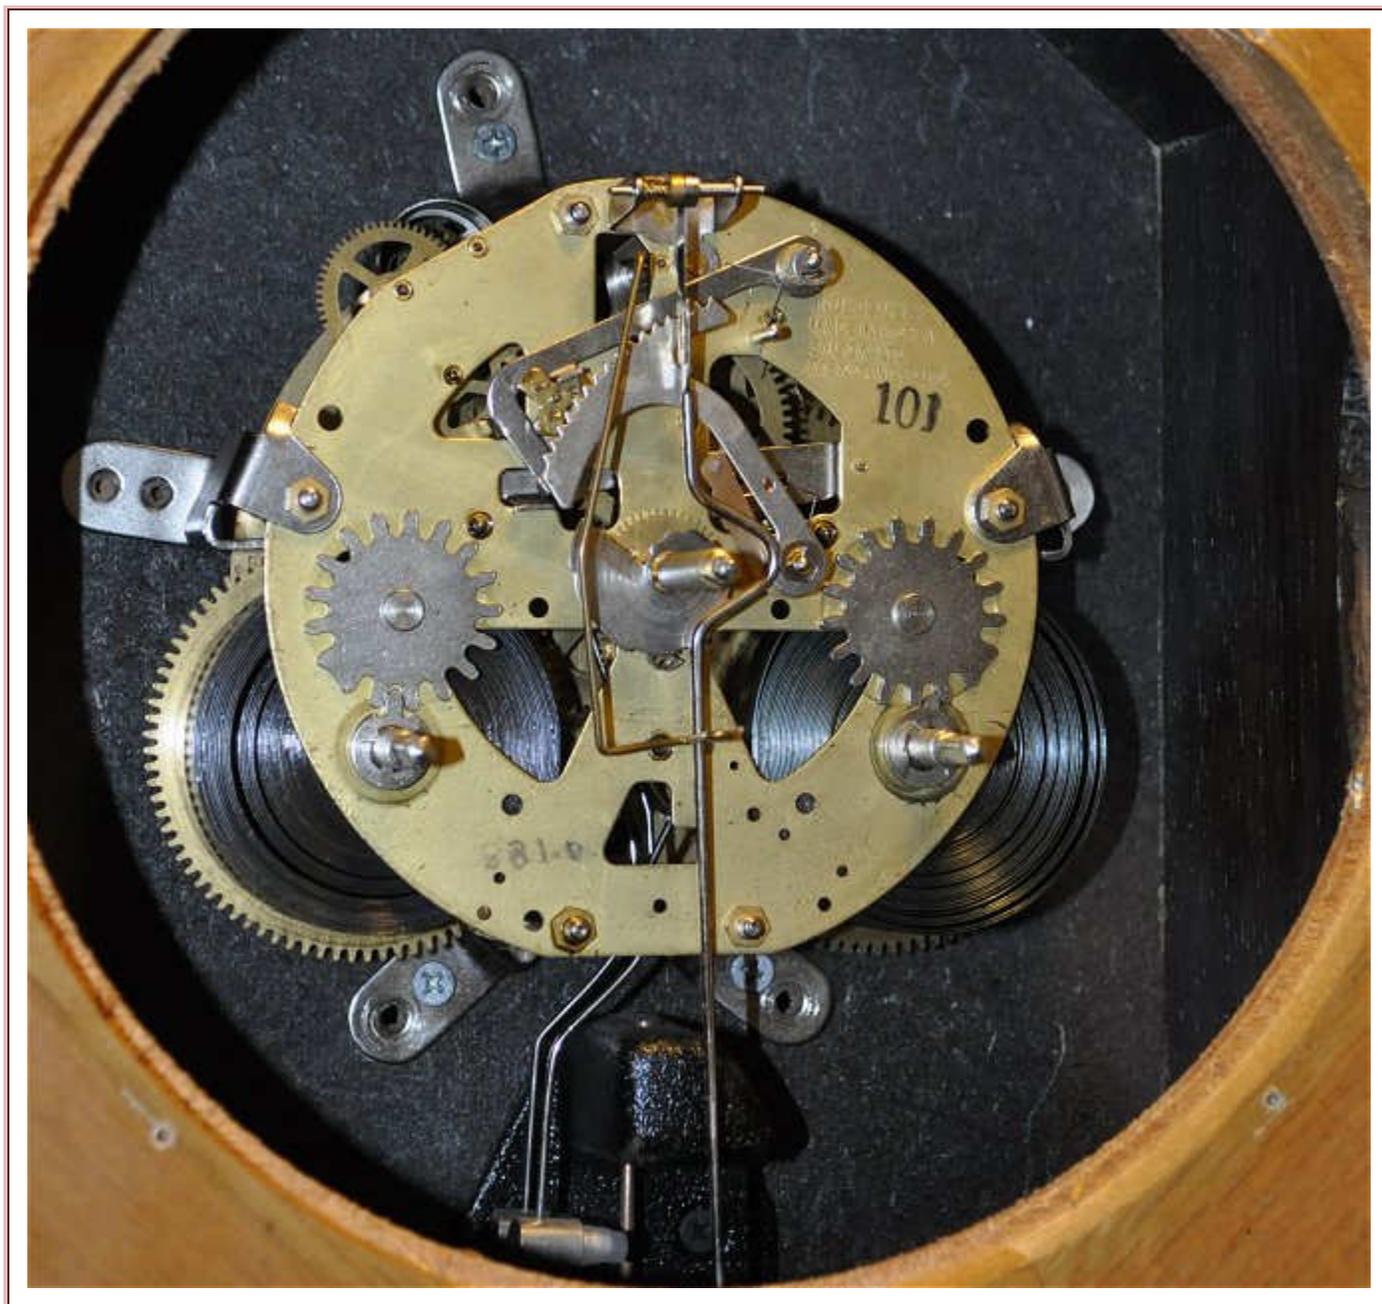
This particular clock does not say "Montgomery Ward" on the dial, but it has the same mechanism. It has a semi-deadbeat escapement because the locking faces of the pallets are not curved, so a small amount of recoil does take place. The clock also has mainsprings that are 3/4" wide, similar to American clocks, so I wanted to compare my Korean clock to my Seth Thomas 89, which also has a semi-deadbeat escapement. Let me quote from a previous essay: "It is worth mentioning that the Timesavers catalog has a 3/4 x 0.015 x 170 inch mainspring for Japanese and Korean 31 day clocks from the 1970s and 80s, because some of their mechanisms look like copies of American clocks from the early 1900s. A 0.015" mainspring, when installed in a Seth Thomas 89, should have a calculated length of 169", and it would have 58% of the strength of a 0.018" mainspring. They were

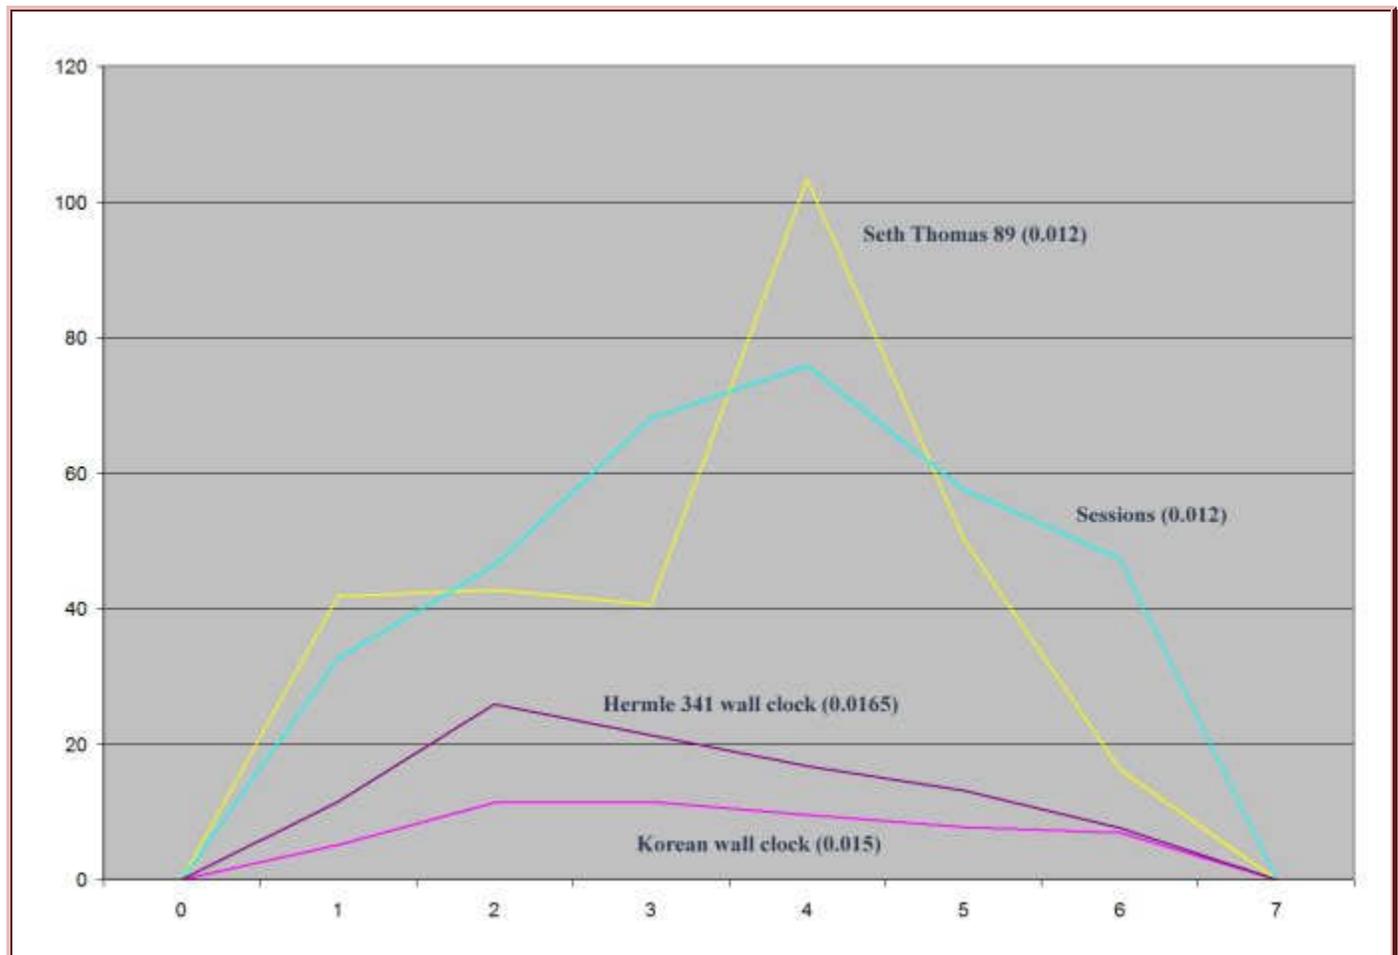
The data confirmed my belief that the Korean clock would be more accurate. However, the data for the Seth Thomas 89 was somewhat irregular, revealing that the mainspring was not the best, so I included the data for two other clocks from my previous essay for comparison. On all the graphs, days one through seven are shown on the horizontal line (X axis). The timekeeping error in seconds is shown on the vertical line (Y axis). Click on each image to see the graph in full size.

A factor that makes the Korean clock last for a whole month is the open barrel. The Hermle 341 would perform better if it had a larger mainspring barrel like the more expensive Hermle 351 or, better still, an open barrel like most American and oriental clocks. The accuracy of the Hermle clock could probably be improved by replacing the mainspring with another German mainspring from a different manufacturer if the Hermle clock was made before the 90s. The 0.0165" mainspring in this experiment was not a

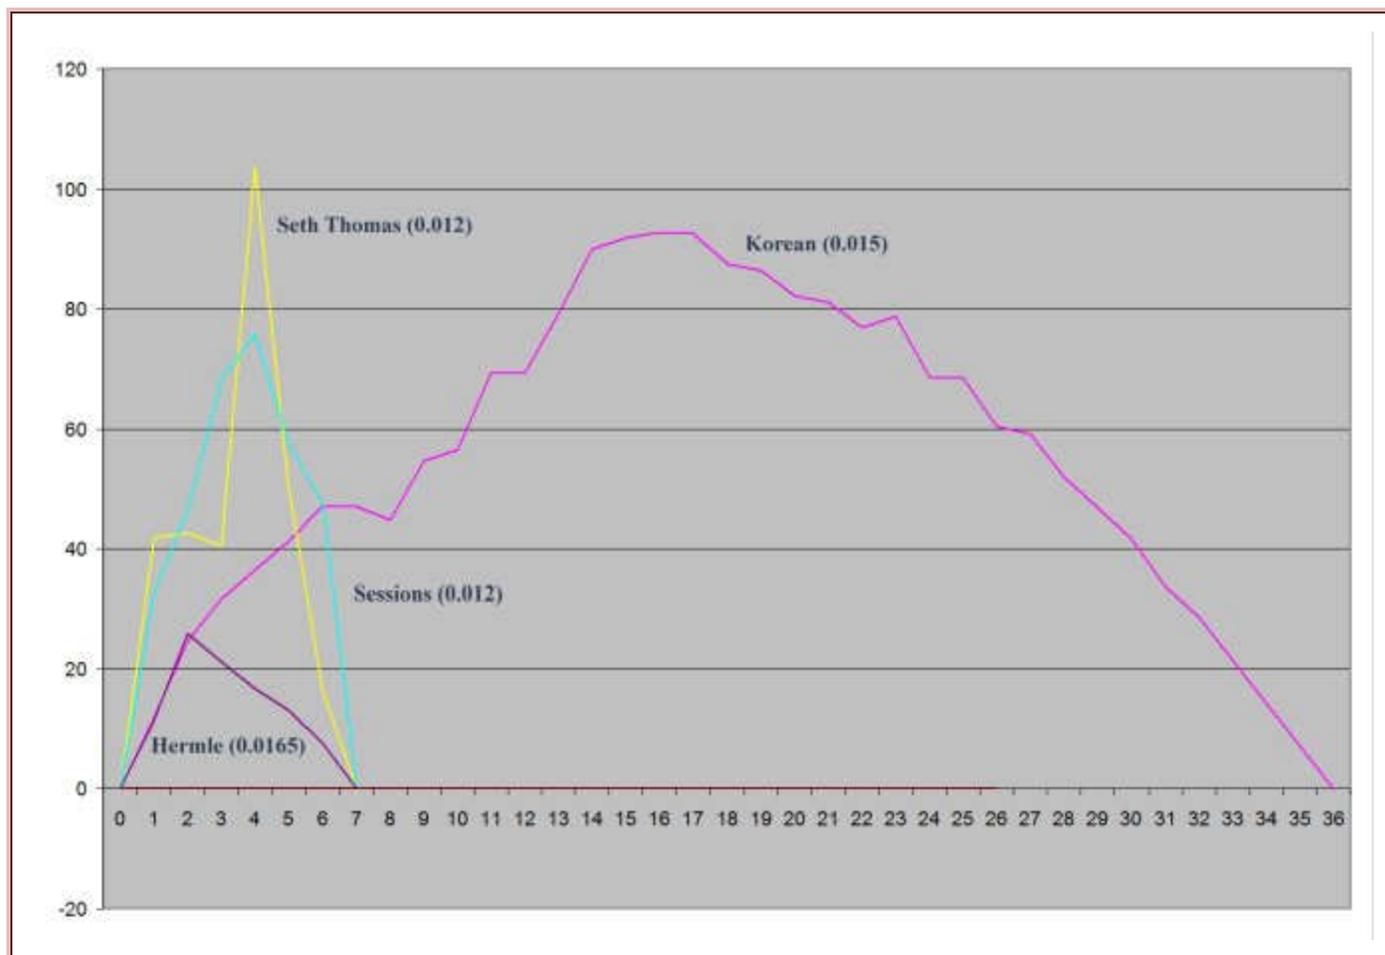
There was more to learn by continuing the test. This clock ran for 36.5 days, and the graph looked like the one below. After six days, the mainspring begins to show modest irregularity. By the end of the month, we can see a curve that reaches a top after 15 days.

Considering a normal 31 day run, an overall error of 75 seconds over 31 days is very respectable for a spring-driven clock. This clock gained 5 seconds per day during the first half of the month, and lost 5 seconds per day during the second half of the month. Few clocks can match that performance. The clock could be made more accurate by winding it twice a month. The overall error would be reduced from 75 seconds to 13 seconds.

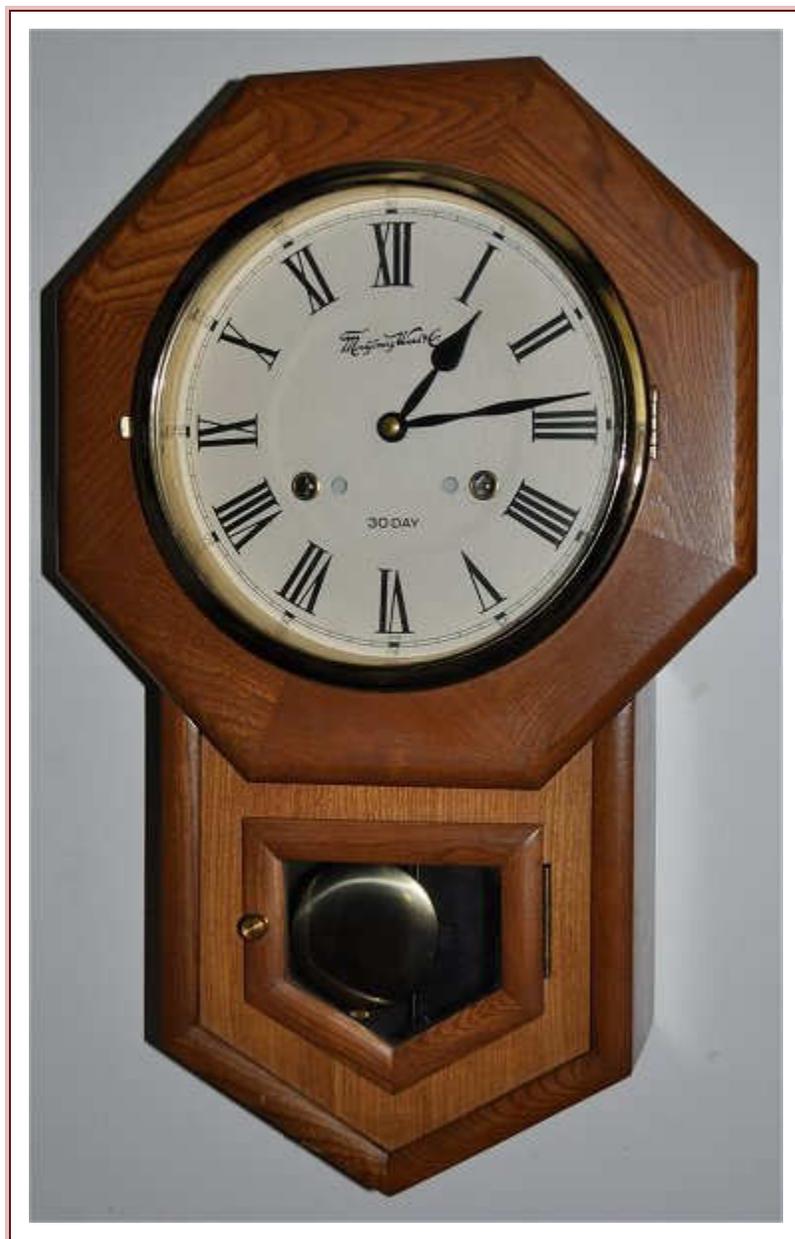
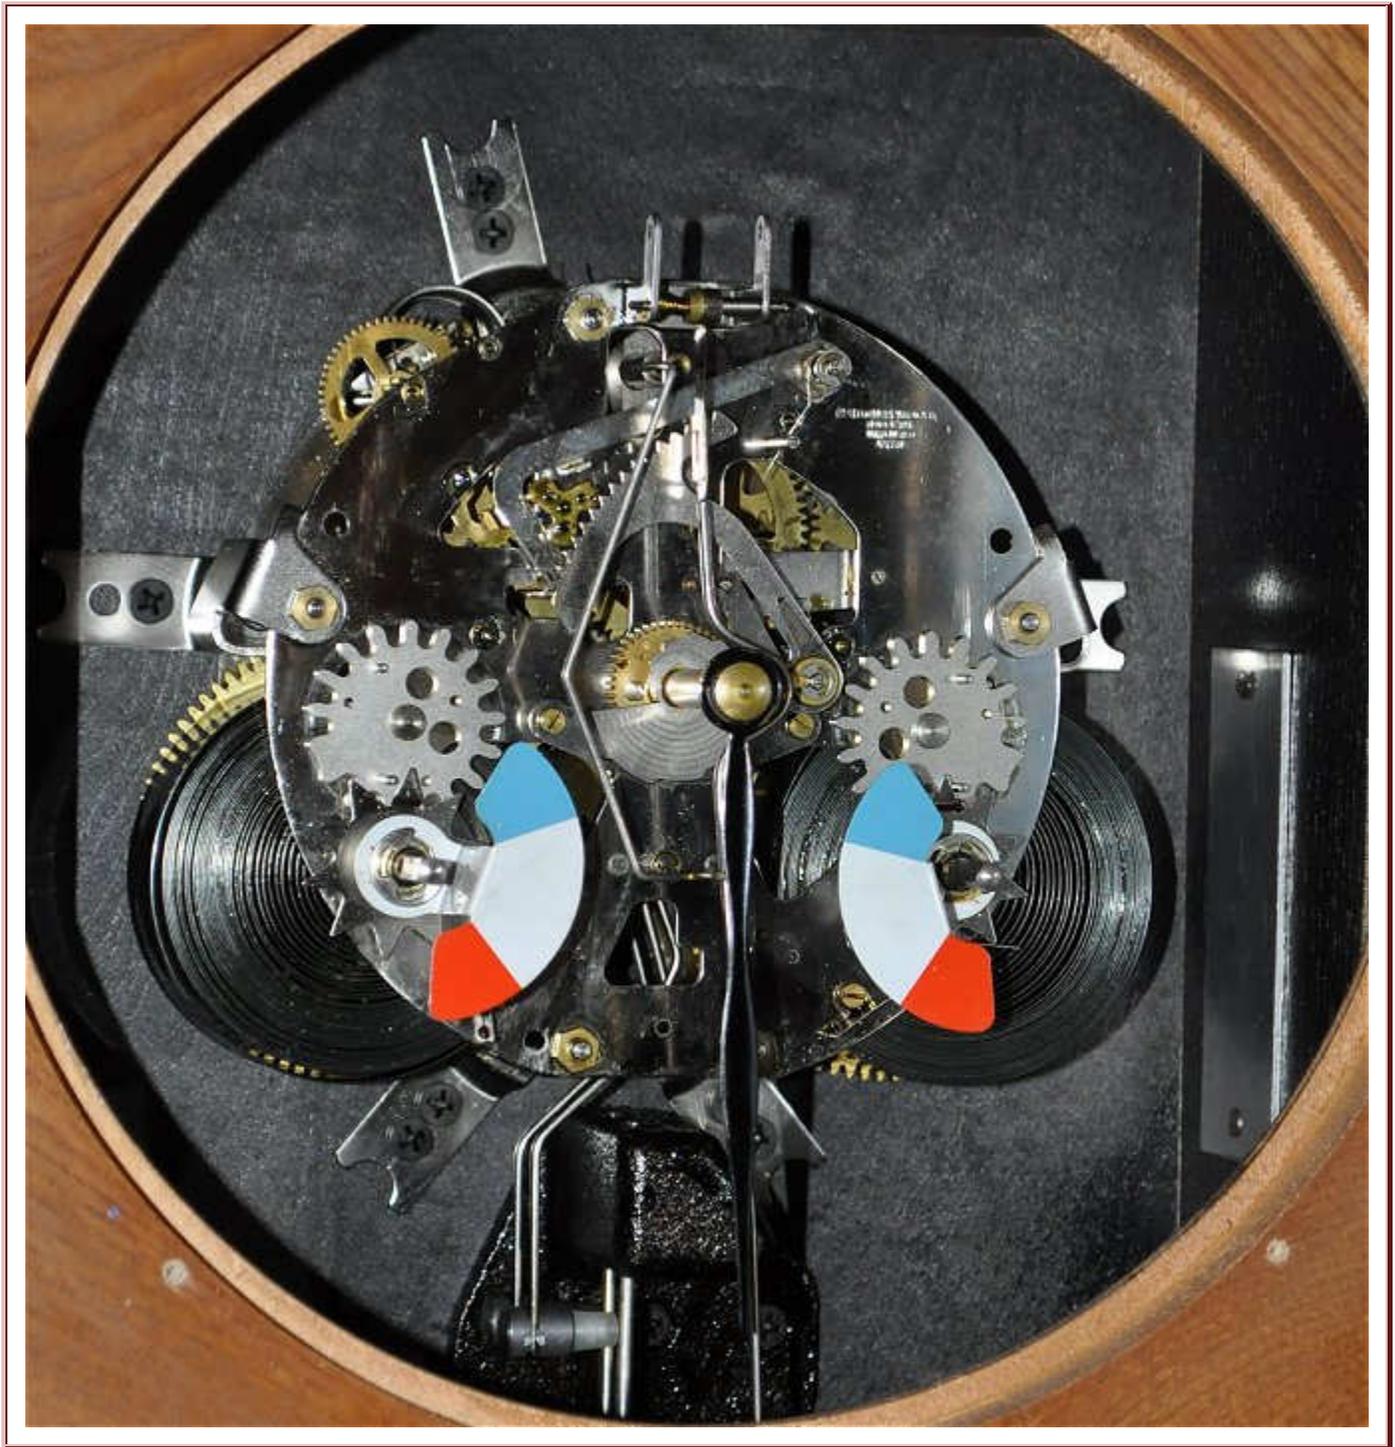
And now, finally, a Montgomery Ward clock made in Japan! This clock has stopworks and wind indicators, and appears to be chrome plated. It is a high-mileage clock with a lot of wear, having served its owner reliably for

many, many years. It was probably made in the late 1960s.

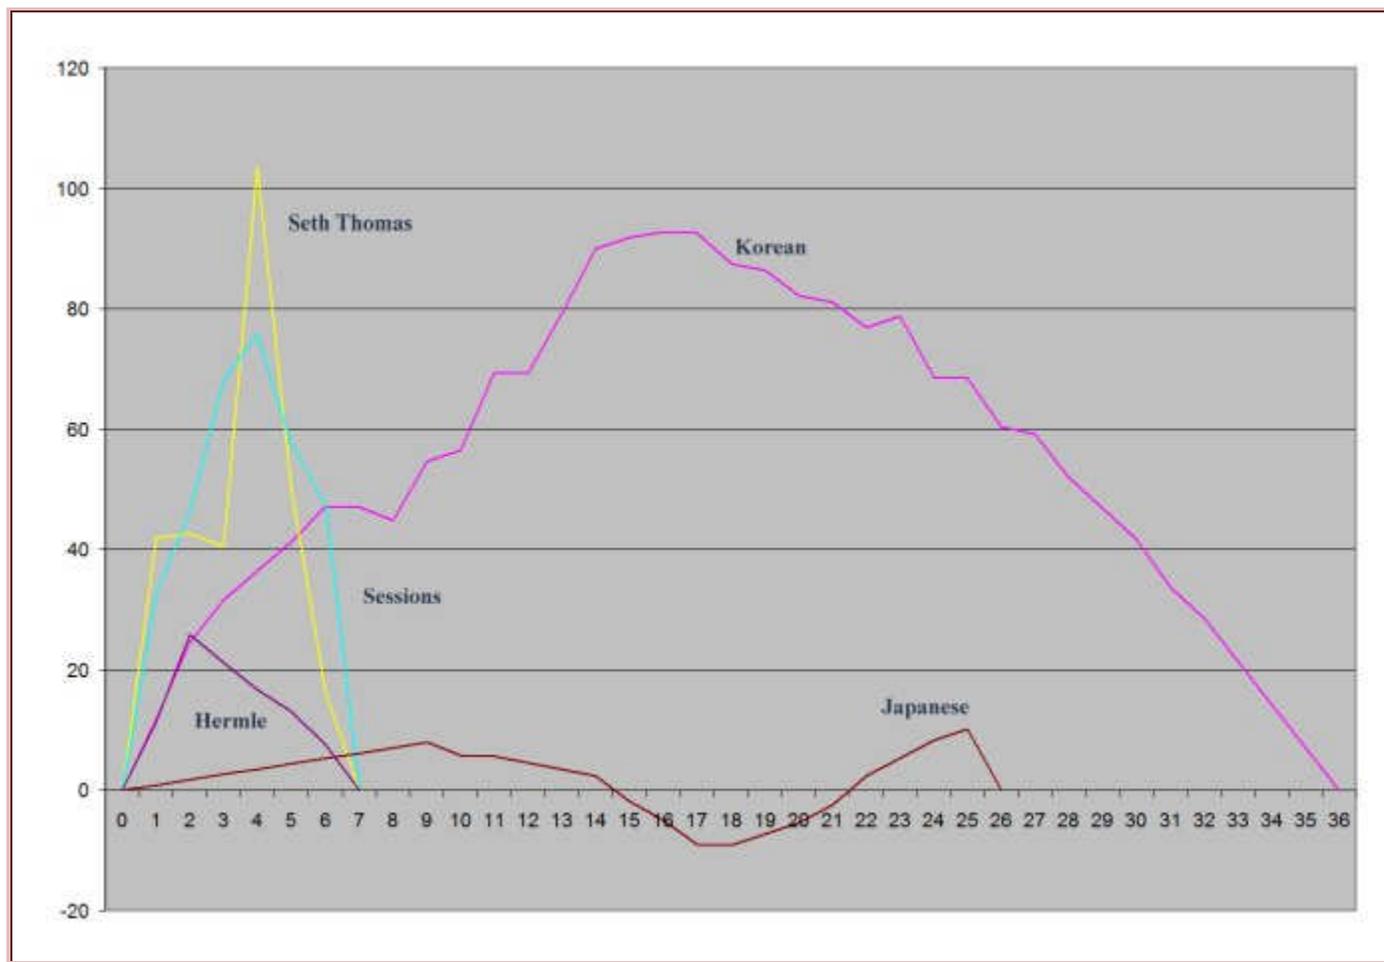
The Japanese clock stopped after 26 days.

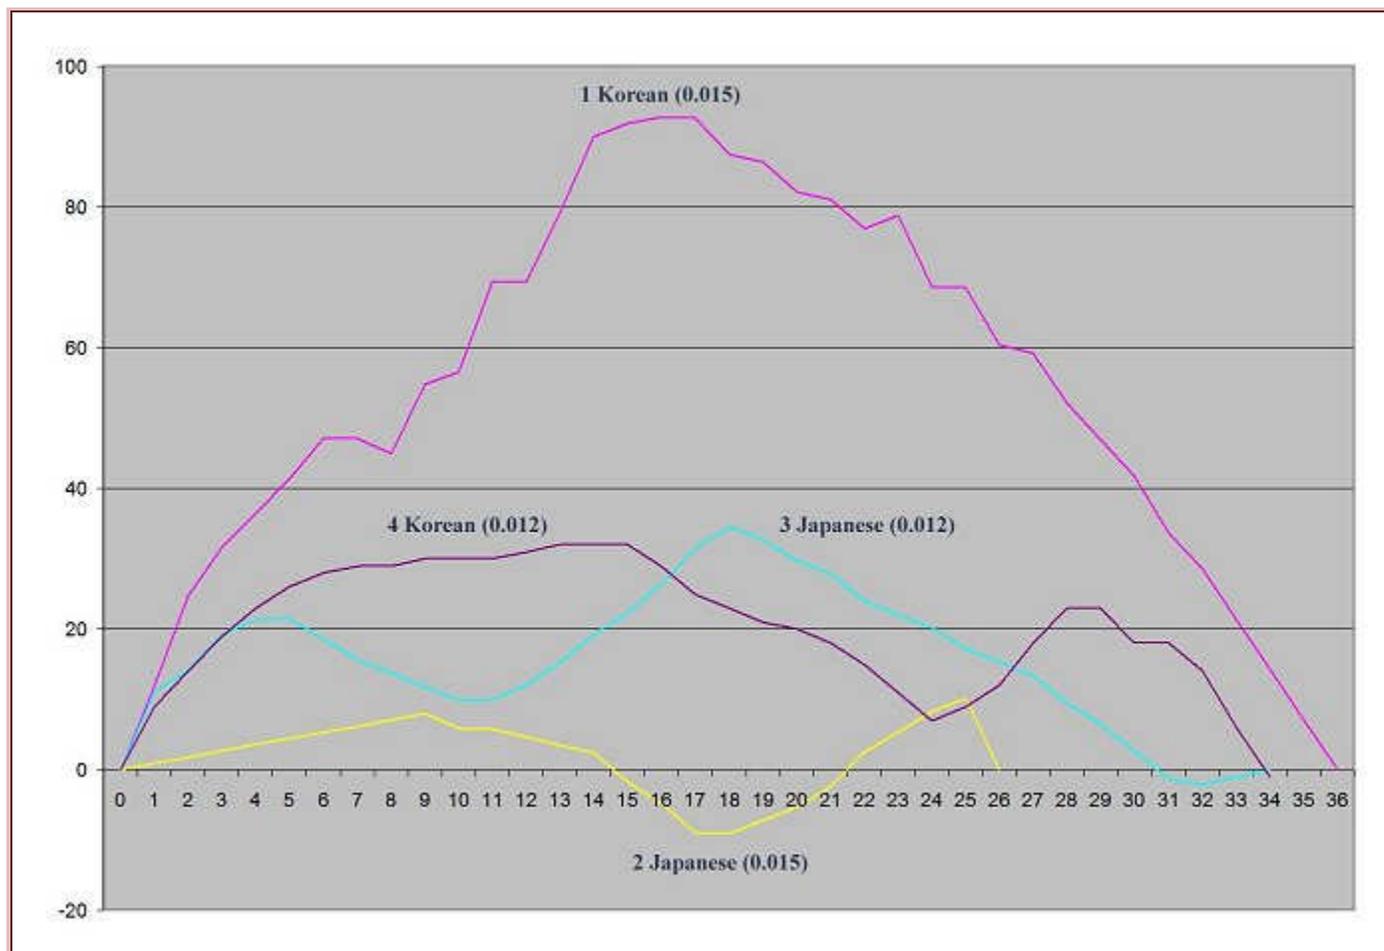
Update: The new replacement mainspring showed a similar curve, reaching a top on the 18th day, comparing lines 2 and 3 in the graph below, suggesting that the variation was more likely caused by the escapement instead, possibly in a longer term trend line. Whereas the old mainspring was 0.015" thick and 170" long, the new mainspring was 0.012" thick, with only half the strength, and was only 70" long. I decided to try it because my spreadsheet for mainsprings calculated that I would get almost 26 turns with the old mainspring, and 23 turns with the new one, so the difference would be small. I polished the pivots of the escape wheel and the fourth wheel, replaced the mainsprings and one bushing. The Japanese clock ran for 34 days with the new mainsprings, (though the strike stopped after 25 days).

With the new mainsprings, the Japanese clock had a maximum variable error of 35 seconds on the 18th day, shown in line 3, or a variable error of about 2 seconds per day. Between the 18th day and the 30th day, the clock gained about 3 seconds per day. Line 4 shows the performance for the Korean clock with new 0.012" mainsprings, which raises more questions than answers because it is more similar to the lines for the Japanese clock rather than Line 1. The data show that by lowering the mainspring strength by 50% will lower the variable error in the timekeeping by at least 50%. Furthermore, the duration of up to 36 days is not affected by the mainspring length by much, shown by replacing a 170" long spring with a 70" long spring. The duration is much more affected by the size of the mainspring barrel, or the amount of space the spring has available to expand in. The photo below shows the Korean clock with the new 0.012" mainsprings. The strike mainspring is fully wound, and barely visible. I left the time mainspring unwound for the photo, so that you could see it.

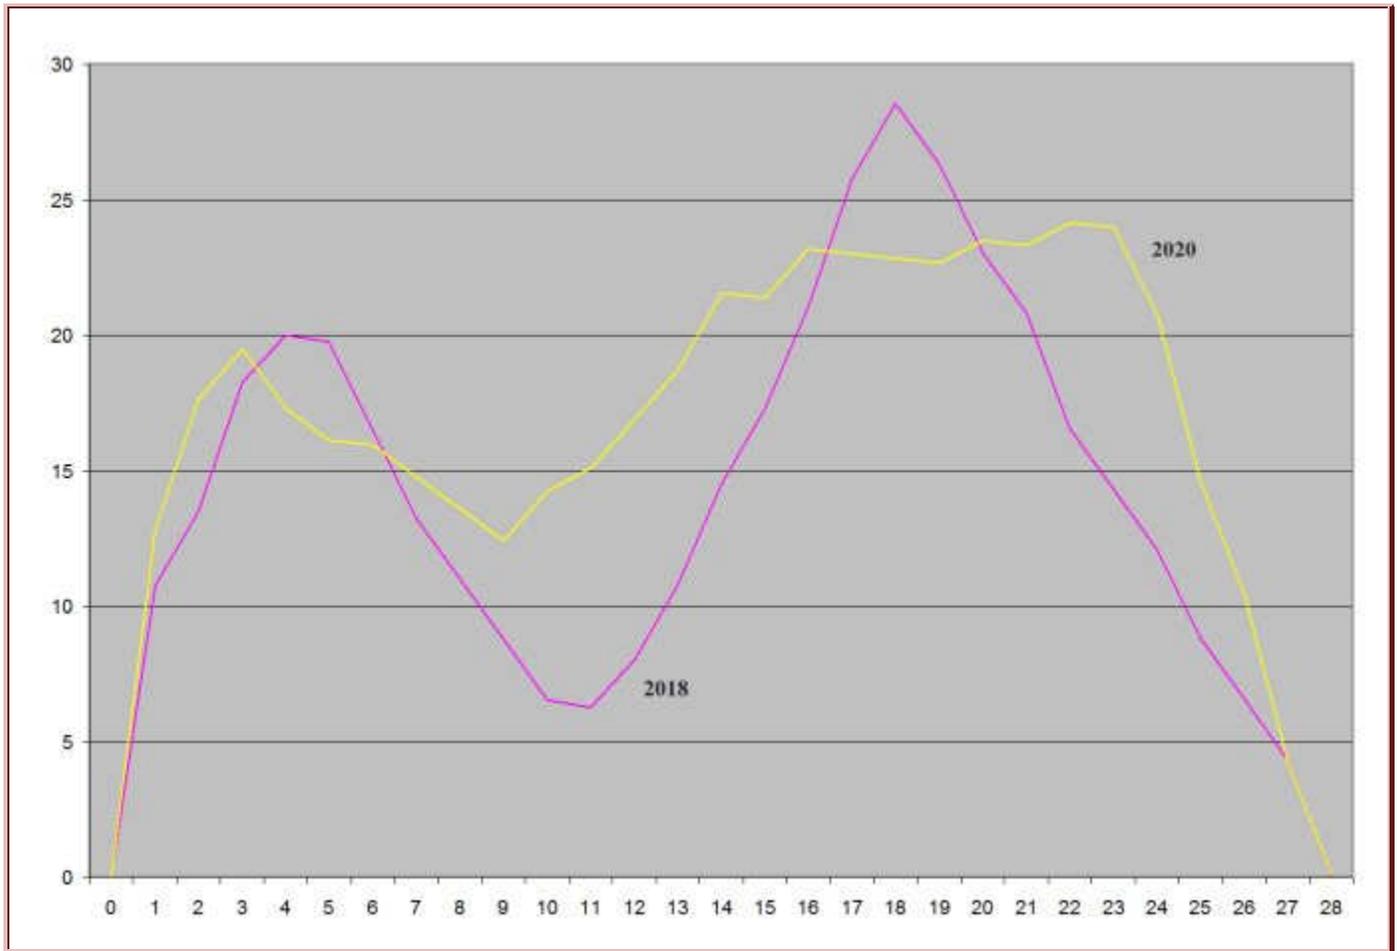
After using the Japanese clock for two years, I decided to repeat the test and compare the results. The mainspring would be expected to lose some strength over time, and the effect on timekeeping could be observed. The effect was small. The biggest change was in duration: the clock stopped after 28 days in 2020, compared to 34 days in 2018. The data from two years ago were taken from the graph above (look for "3 Japanese (0.012)") and modified to bring the variation in timekeeping, on the vertical axis, to zero on the 28th day instead of the 34th day, so that the two curves could be compared. The days are shown on the horizontal axis. For a mechanical clock to have a maximum cumulative error under 25 seconds over a 28 day period is really good.
